The Visible
“Red Flags”
of Implementation Fraud:
Roads, Structures, Equipment

In the slides ahead, you will see the visible **red flags** of fraud and corruption in project implementation

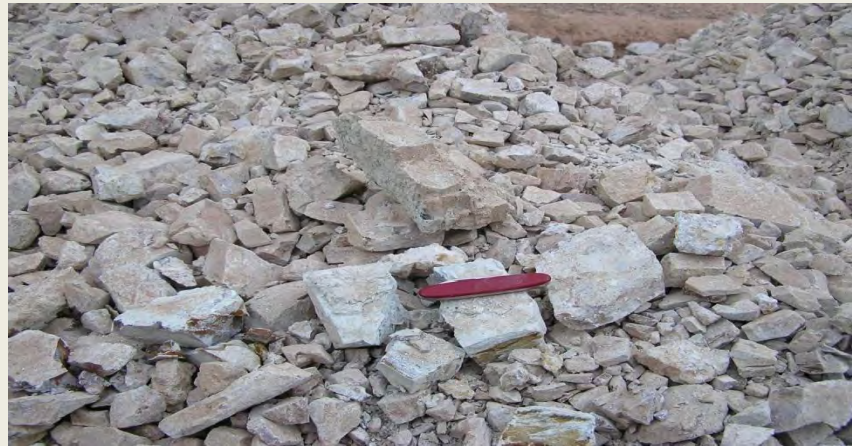
Use of improper base and sub base materials

The top photo shows gravel stored at a contractor's job site that was to be used to build a gravel road. Many of the stones were larger than that permitted by the contract specifications, and their use would have weakened the compaction of the road, leading to its early deterioration.

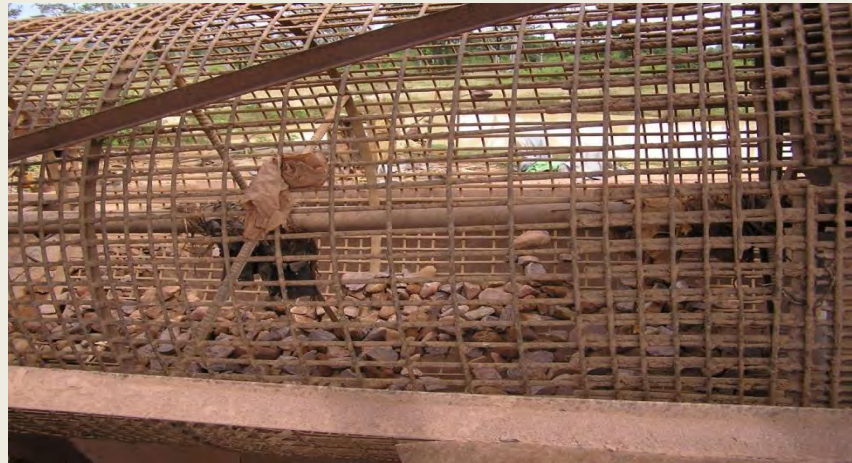
The lower photo shows that the contractor removed mesh from the screen used to sort the gravel in order to allow the larger stones to pass through. This would have resulted in considerable savings for the contractor.

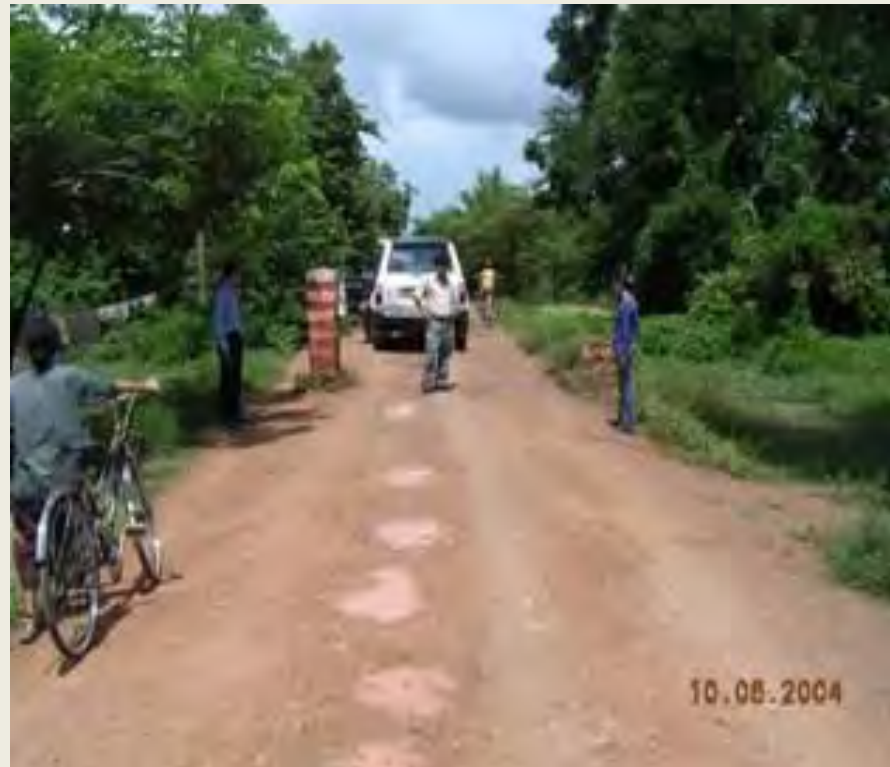
Use of inadequate base and sub base materials, continued...

Pot holes, such as those shown here, which appear shortly after a gravel road's construction (within the first one to two years after construction) can indicate an inadequate foundation that causes the road to compress along the tire tracks, creating compressions that become potholes. Inadequate compaction and drainage can worsen the problem.

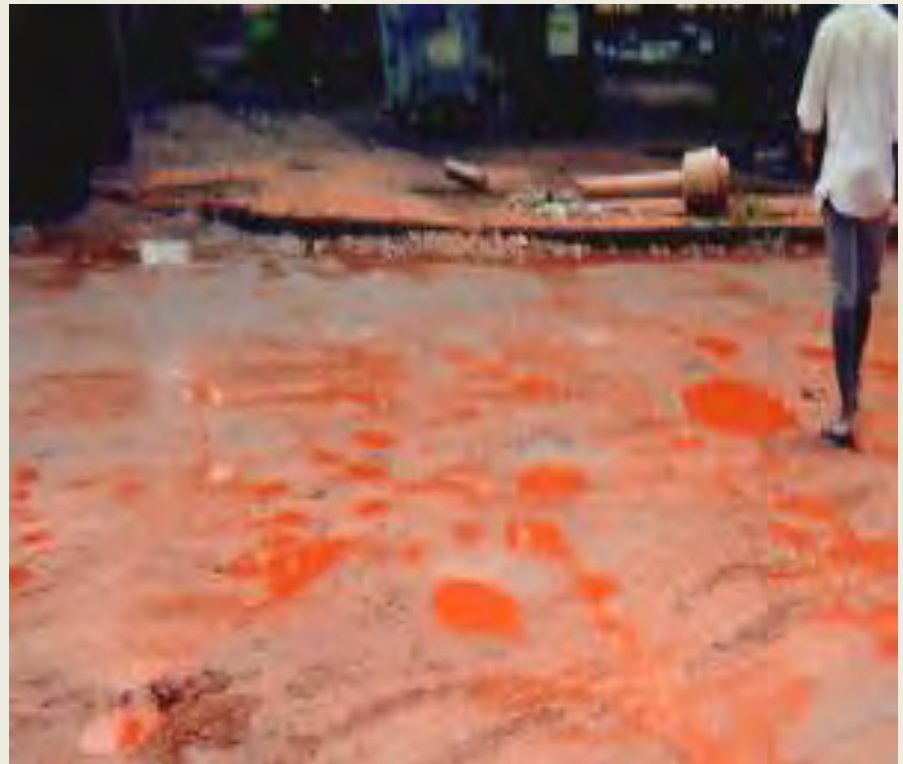
Results of inadequate foundation and surfacing materials, compaction and drainage...

This road (the same one pictured on the first slide below the house) is shown thirteen months after its completion. It was designed to be an urban asphalt road with a useful life of 10 years.

According to local witnesses, the contractor failed to lay an adequate foundation or surfacing materials and failed to provide drainage or to compact the road according to specifications, with the result that the road was largely unusable after the next rainy season.

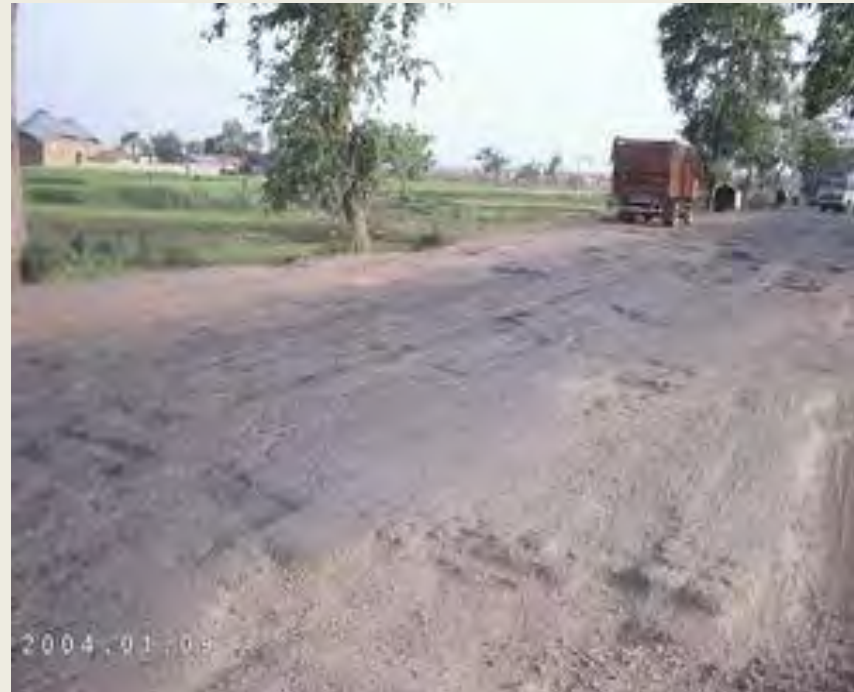
Inadequate base, sub-base and drainage

This road was constructed with a gravel base and sub-base and asphalt surfacing.

The road surface failures were caused by a break down of the base and sub-base, which could have been caused by the improper grading of the gravel used, inadequate compaction and poor drainage.

These factors caused the under layers to compress, and the asphalt surface to crack and disintegrate with the formation of severe potholes.

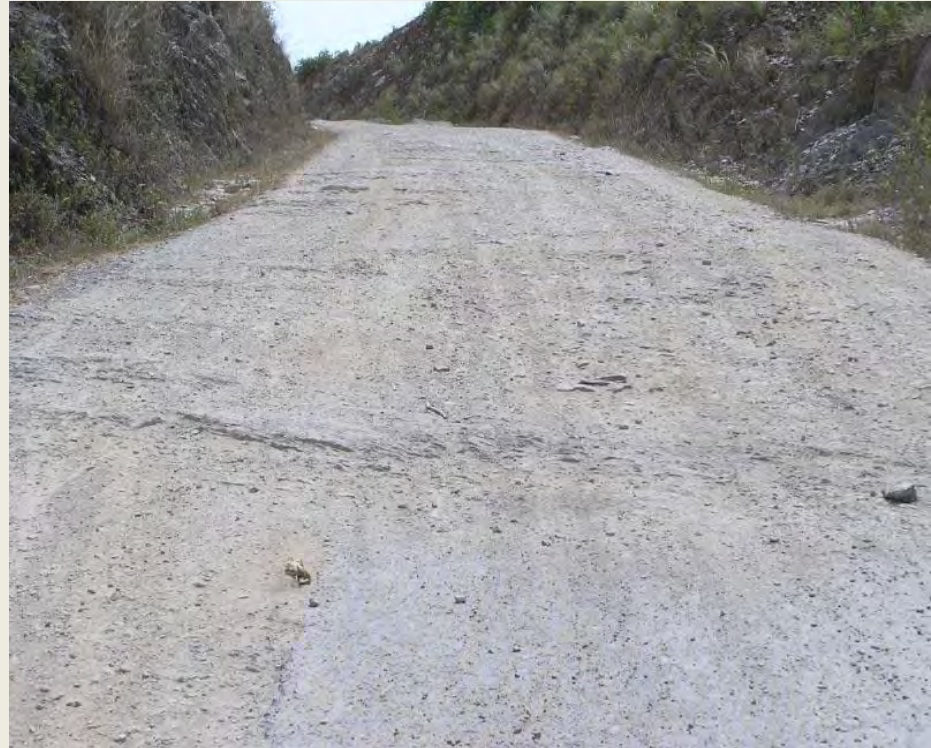
Inadequate foundation and surface materials ...

In fact, in the road segment shown here, the contractor laid *no sub-base, base or surfacing materials at all*, instead delivering the road with a bare rock surface, which, as a further failure, was not cut down to the specified depth.

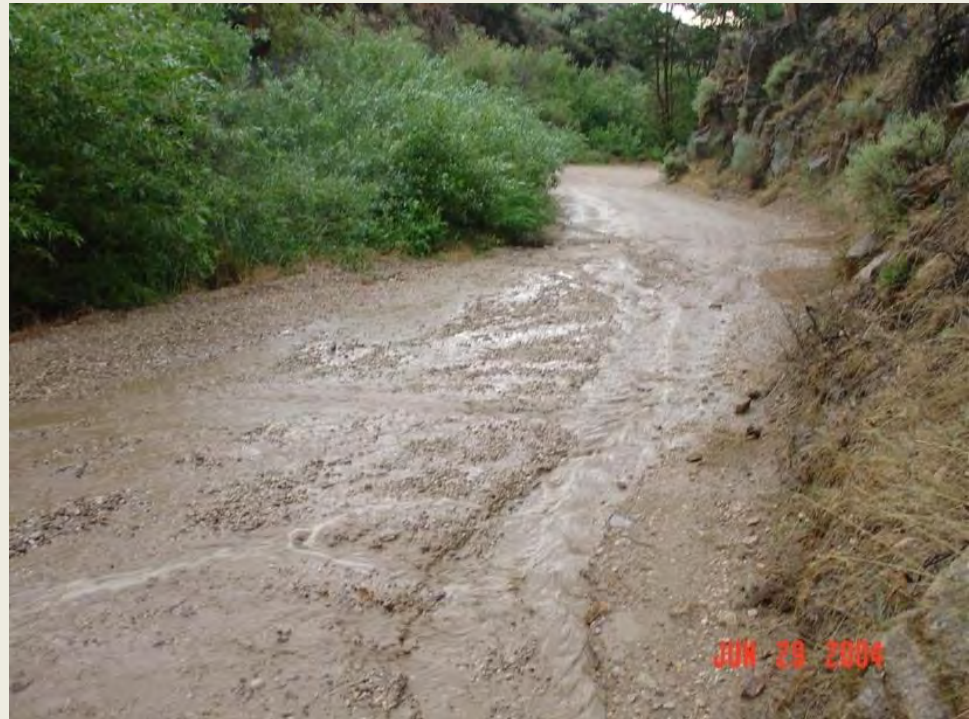
A good example of inadequate drainage ...

Excessive water flow eroded the road surface because of inadequate drainage; the absence of drainage ditches and culverts along the sides of the road to carry the water from the road surface can be seen in the photo.

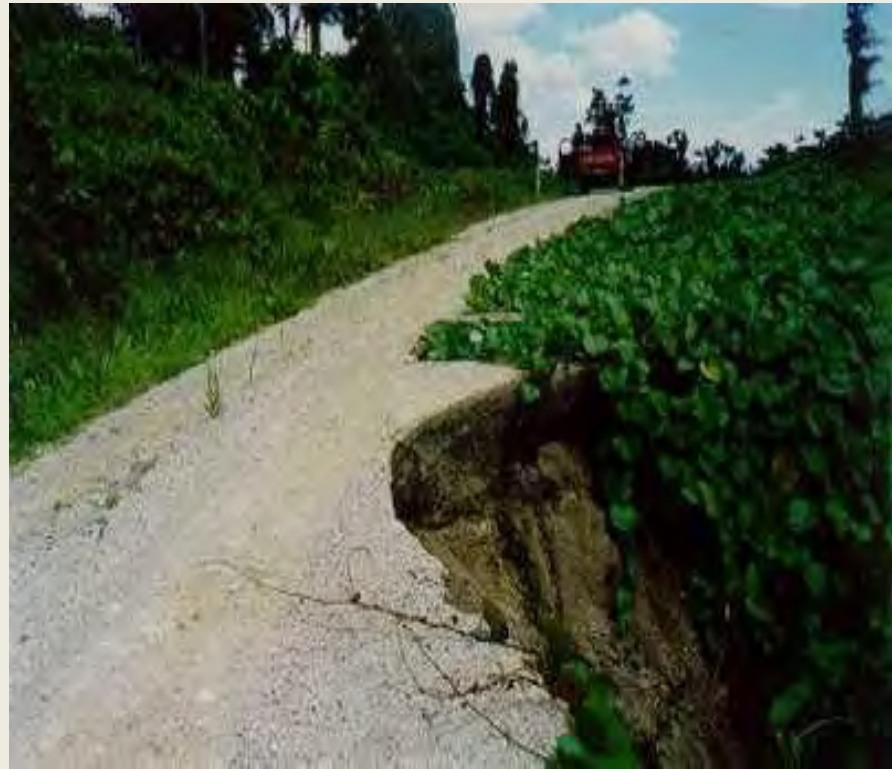
A stark illustration of the impact of inadequate drainage on a road surface...

With no drainage ditch or culverts on the interior side of the road to collect and dispose of the surface water, the water flowed over the road surface and down the hill side, eventually eroding the road embankment.

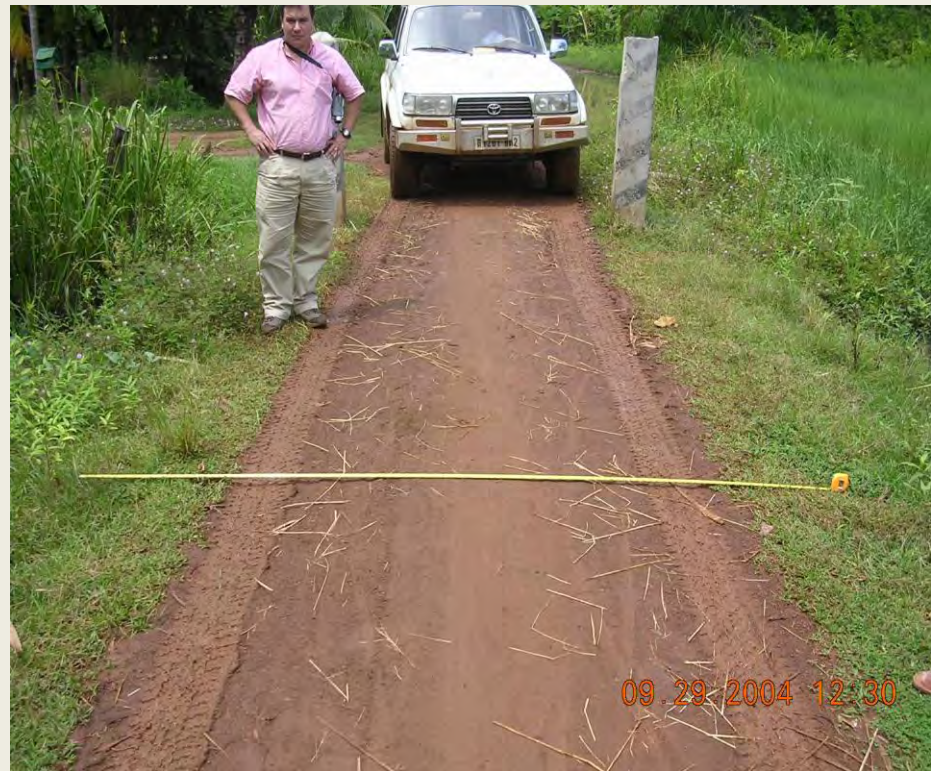
The road at right was 30% narrower than
required by the contract specifications,
and was delivered without the required
surfacing... yet the contractor was paid in
full.

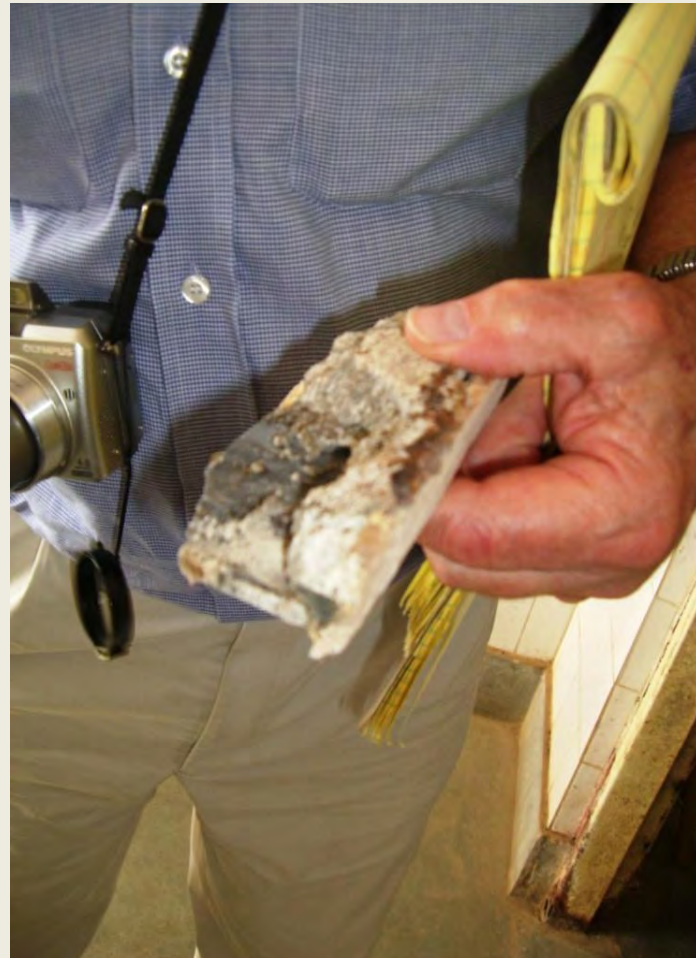
The photo at the right shows poor quality building materials found at a hospital construction site, which failed and broke off before the building was ever occupied.

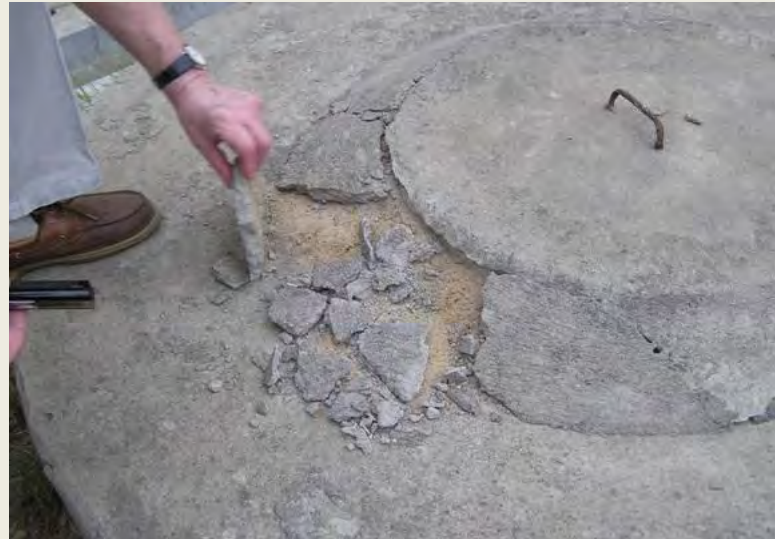
The top photo is of crumbling mortar on a recently constructed drainage system at a hospital;

Both failures were due to inadequate cement content in the mortar (which is mix of sand and cement) and concrete (a mix of sand, gravel and cement).

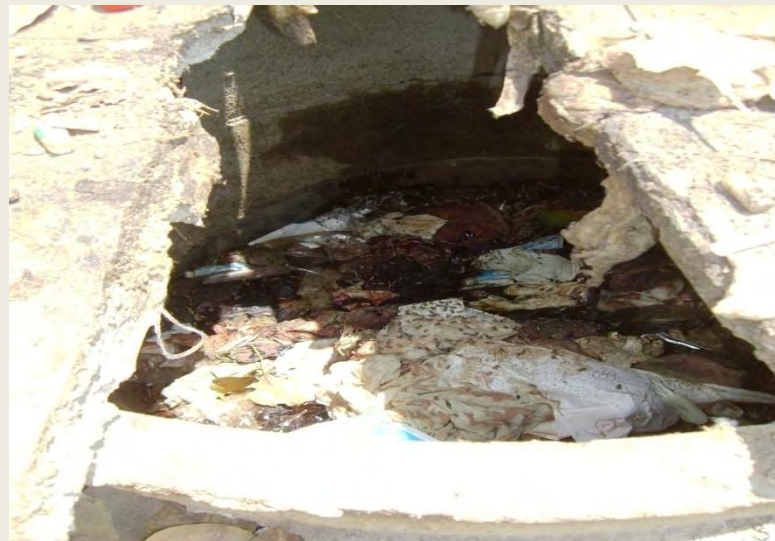
The bottom photo shows a cracked concrete cover on a hospital refuse pit, exposing decaying human and biological waste.

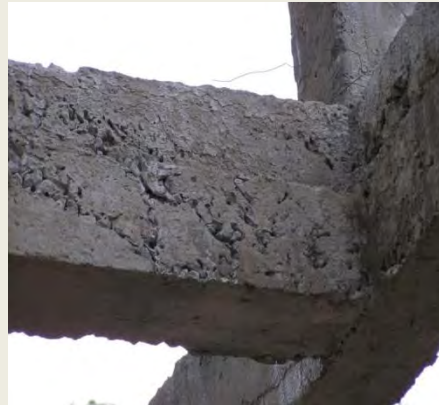
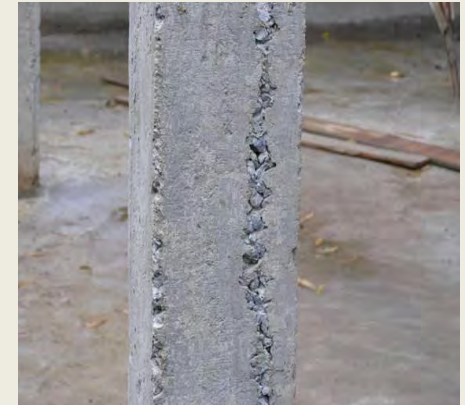
The photos at the top left and right show the results of inadequately vibrated concrete, which allowed air holes (visible as the pock marks on the concrete) to form in and weaken the columns.

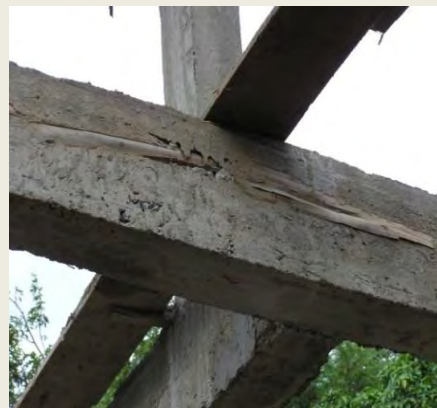
The photo in the lower left also shows pieces of bamboo carelessly mixed in with concrete.

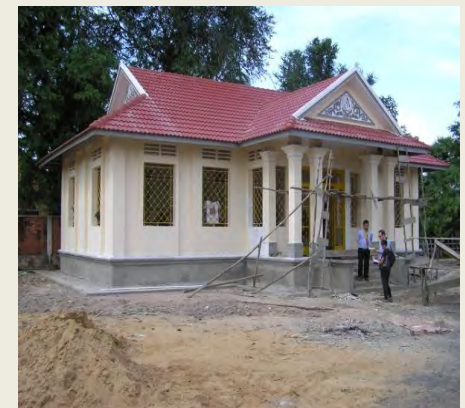
Such shoddy practices can be hidden by the building's exterior (see the completed building on the lower right) but will weaken the structure and cause it to collapse if sufficiently stressed.

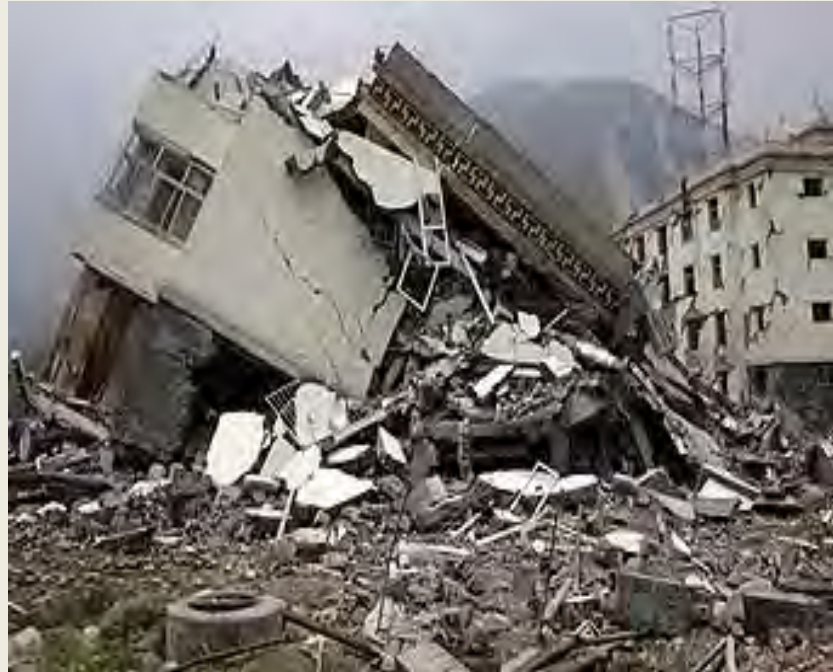
Collapsed school in China as the result of the earthquake in Sichuan Province, attributed to weak concrete content and inadequate steel reinforcement, resulting from the alleged corruption of state supervisory personnel.

Other better-constructed structures nearby were virtually undamaged.

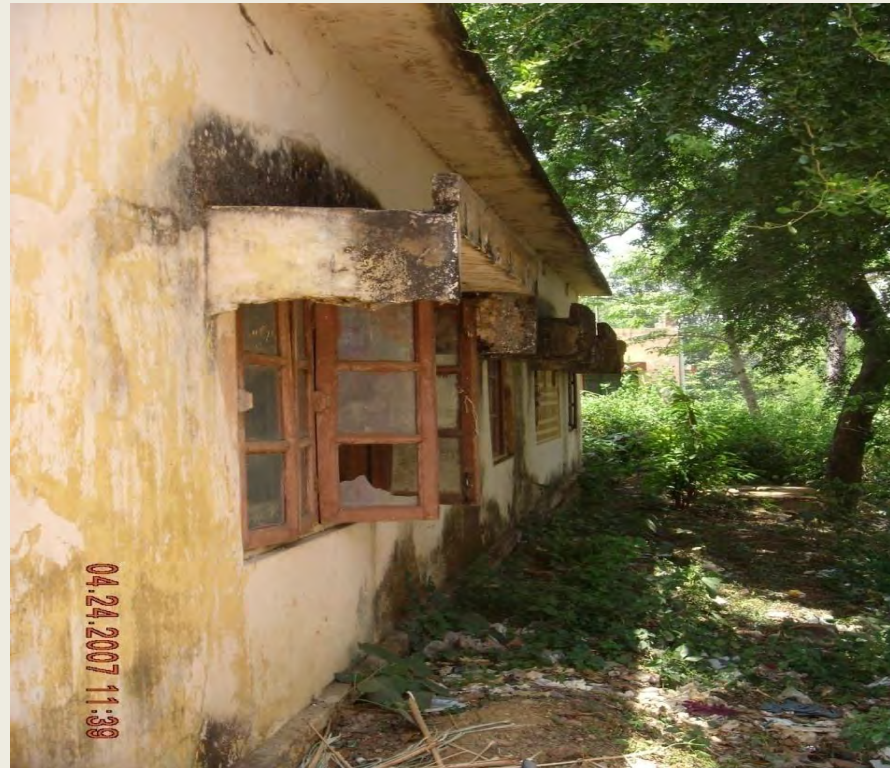
This purportedly “rehabilitated” hospital wing was delivered, accepted and paid for, with no signs that any of the contracted work was performed. Note the broken windows, ground conditions, etc.

The black mold on the concrete mortar indicates a low cement content; properly mixed mortar resists water penetration and the mold that results.

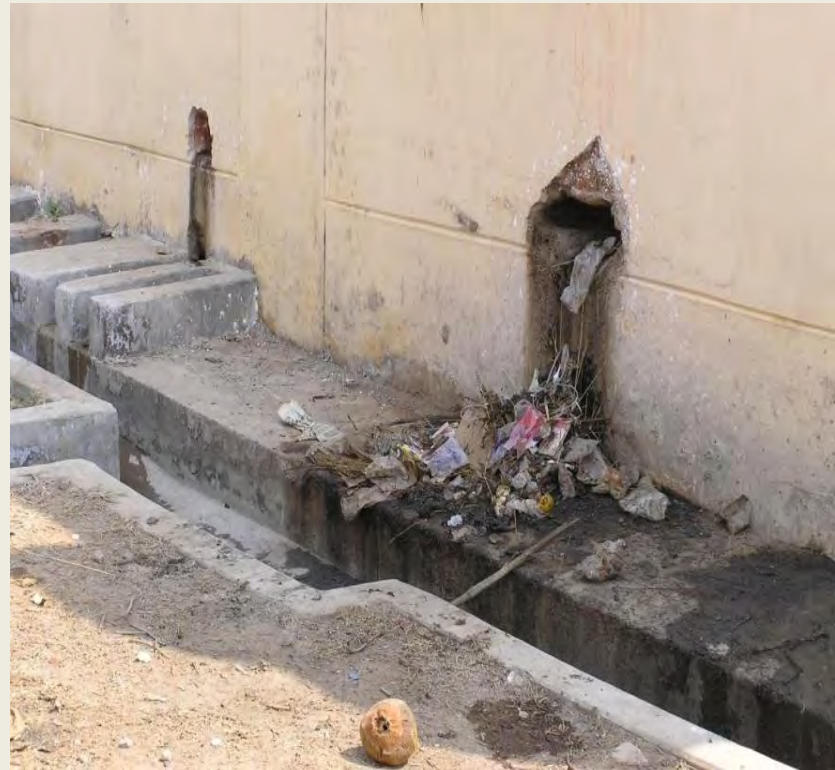
This photo shows a hole in a hospital wall from an interior toilet area allowing debris and waste to flow freely out ... a clear indication of substandard work facilitated by inadequate or corrupt supervision.

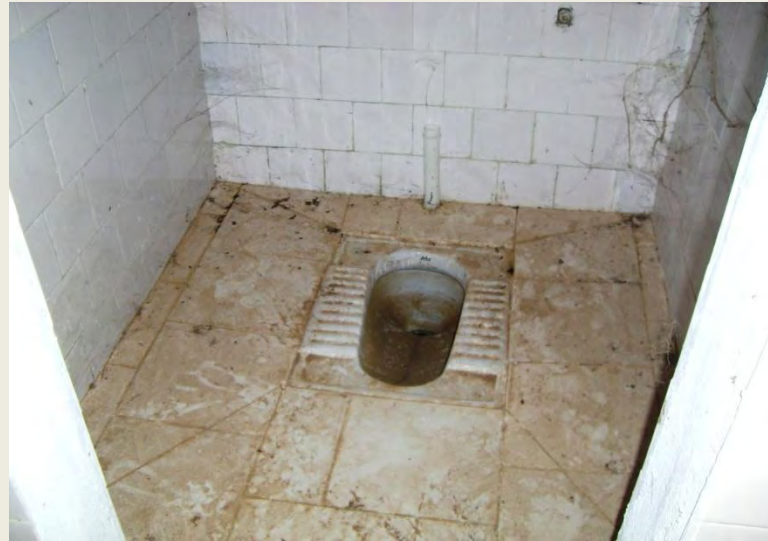
The top photo shows a toilet in a delivered and accepted hospital without any connection to a water source.

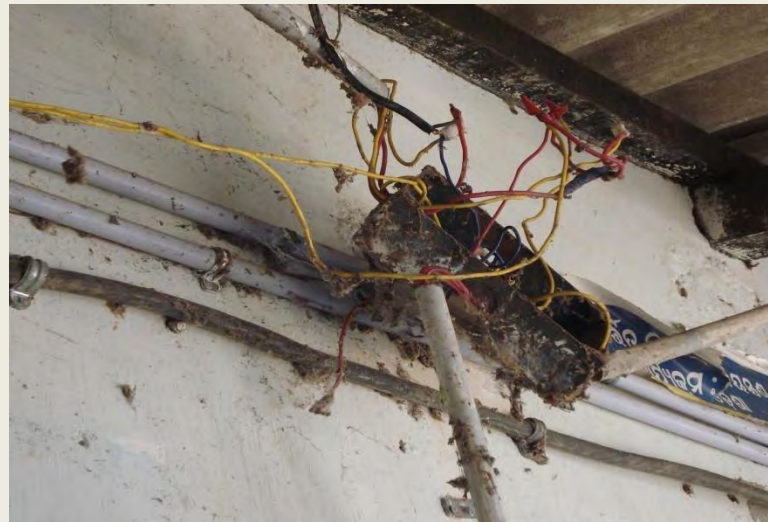
The bottom photo is of shoddy, incomplete and dangerous exposed electrical wiring in another delivered and accepted hospital.

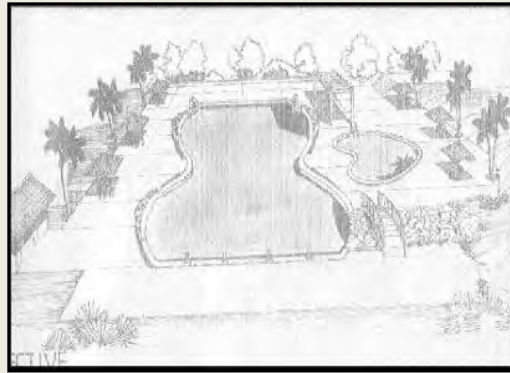
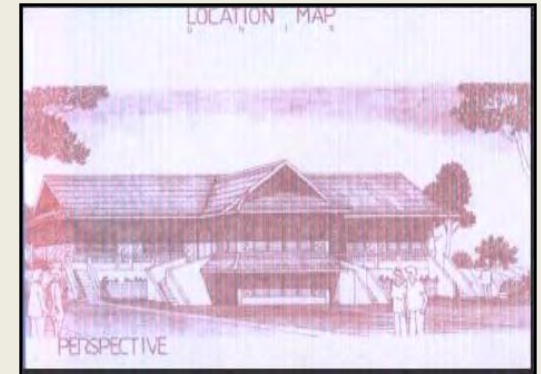
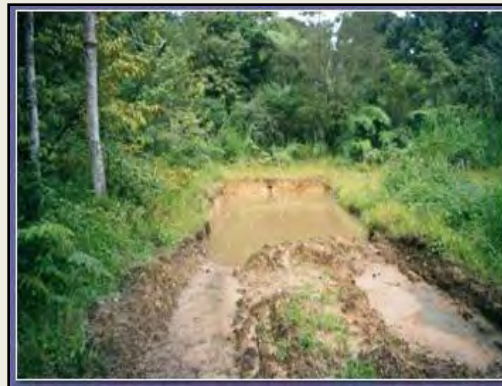
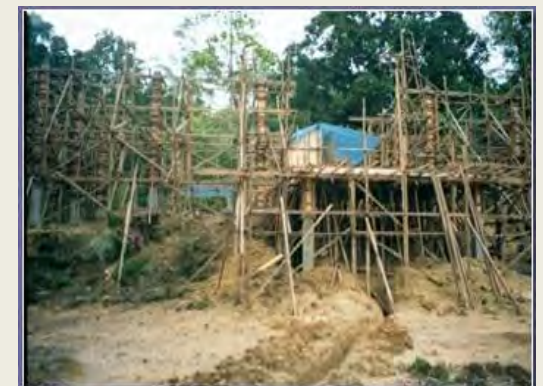
The drawings on the top left and right show the design for an Eco Tourism Center; the photos on the bottom show the status of the construction with more than 50% of the funds disbursed and less than 30 days to scheduled completion.

The photos also reveal possible fraudulent “front loading” of billings by the contractor, as well as, yet again, inadequate or corrupt supervision.

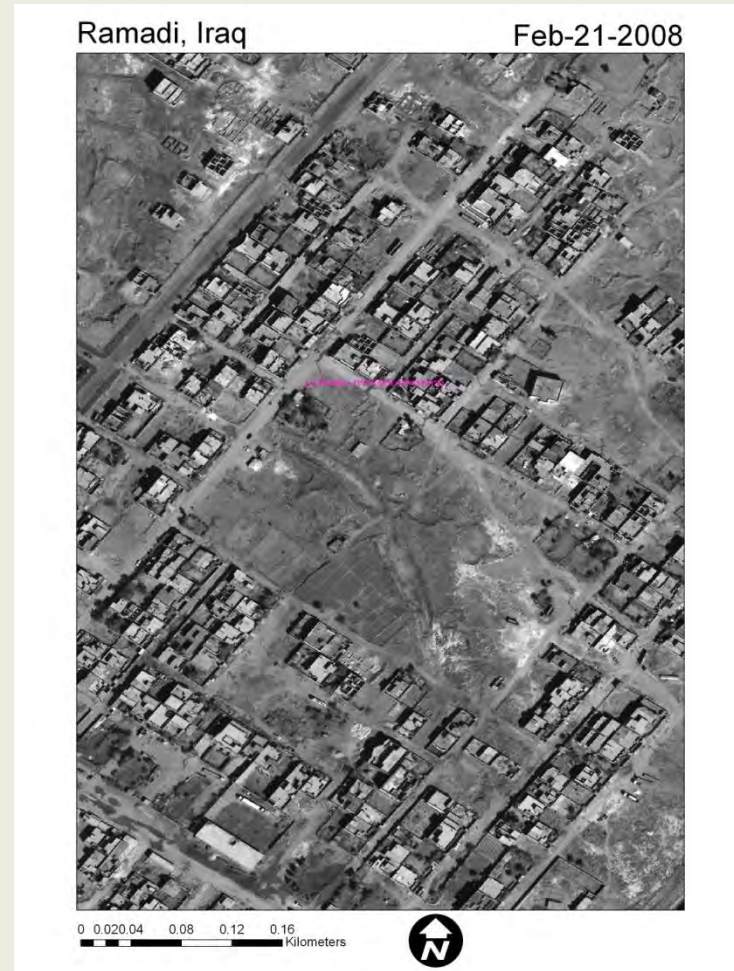
A school was supposedly built on the site shown in this satellite photograph, which shows an empty lot.

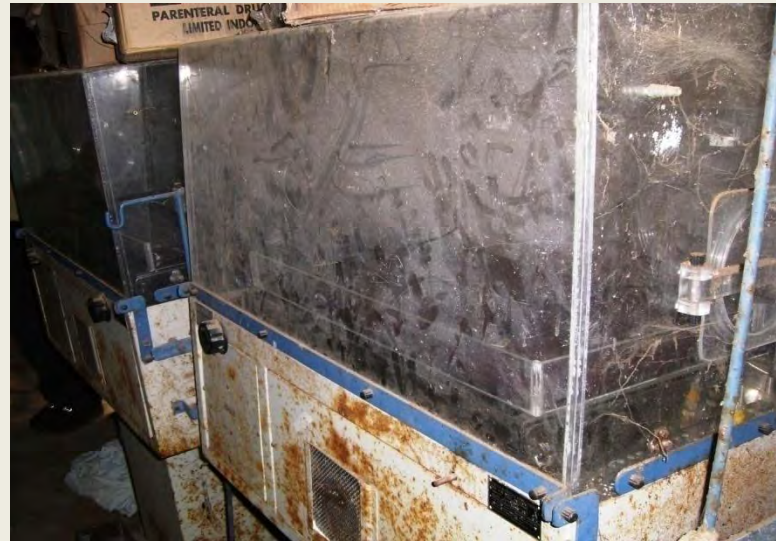
The top photo is of a purportedly “new” and unused baby incubator.

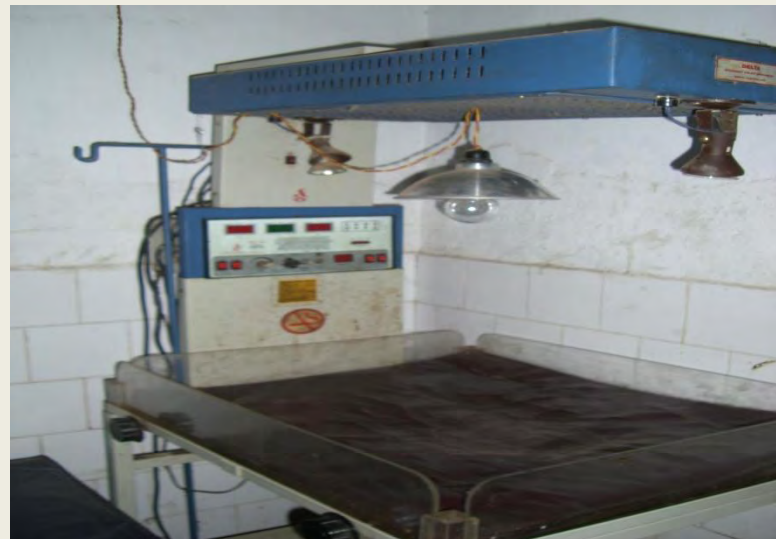
The bottom photo shows a standard light bulb substituted for a defective radiant lamp, creating a severe health risk for the exposed infant.

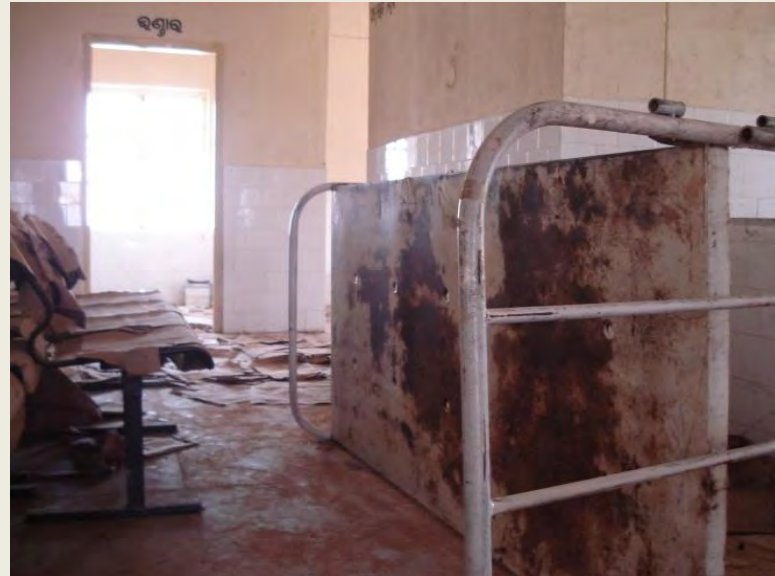
Top photo: hospital room with rusted
bed frame

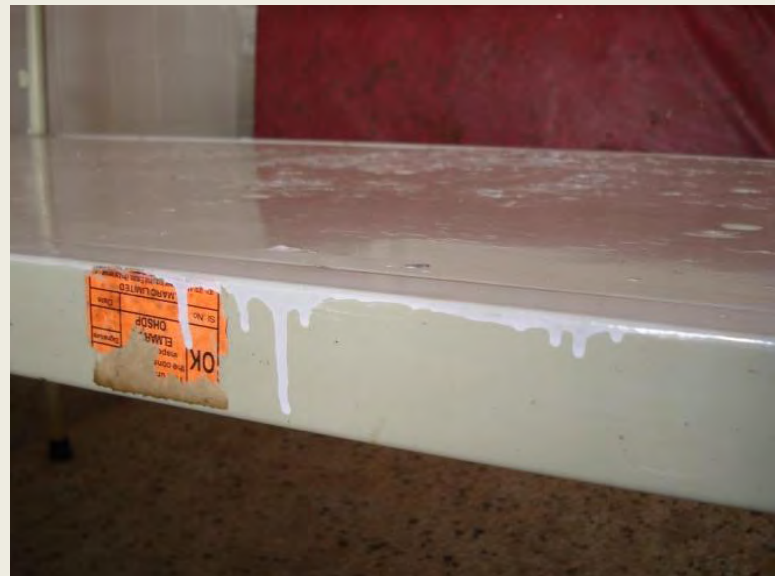
Bottom photo: spray paint over rusted
bed frame, a good indication of
fraudulent intent by the supplier or
recipient

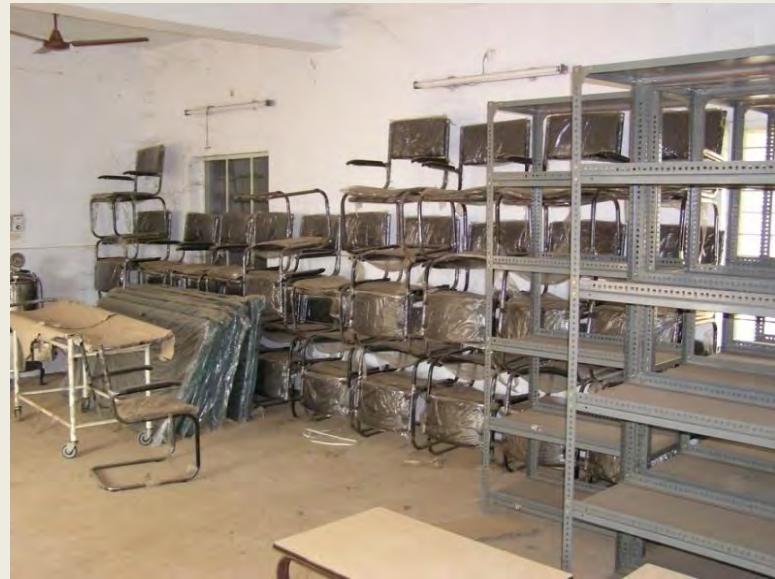
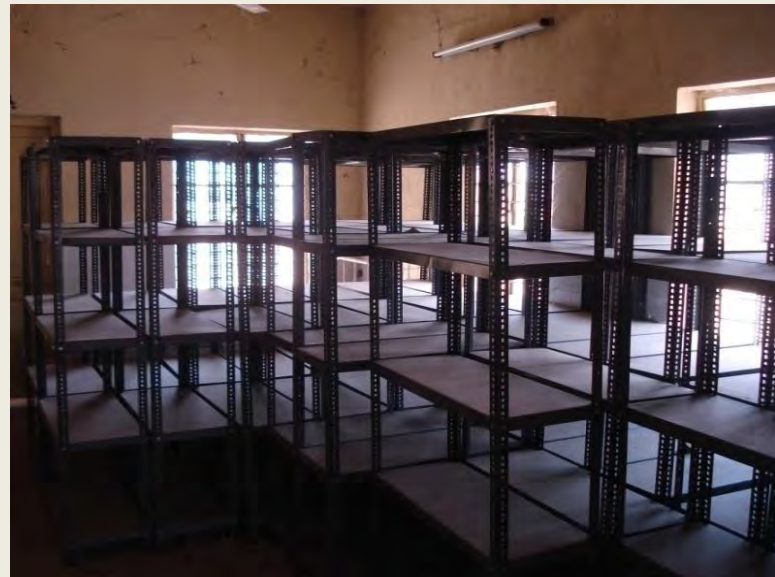
Over purchasing of items

The photos show the purchase of excessive quantities of standard office equipment, an indication of possible kickbacks by the suppliers to the project procurement staff.

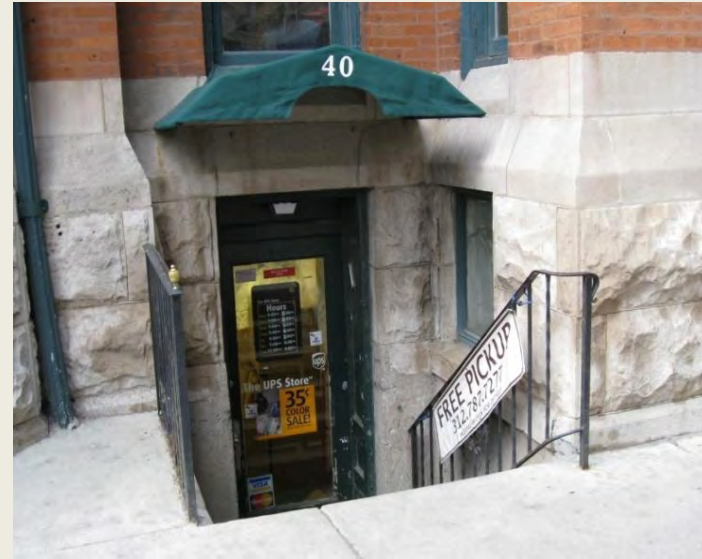
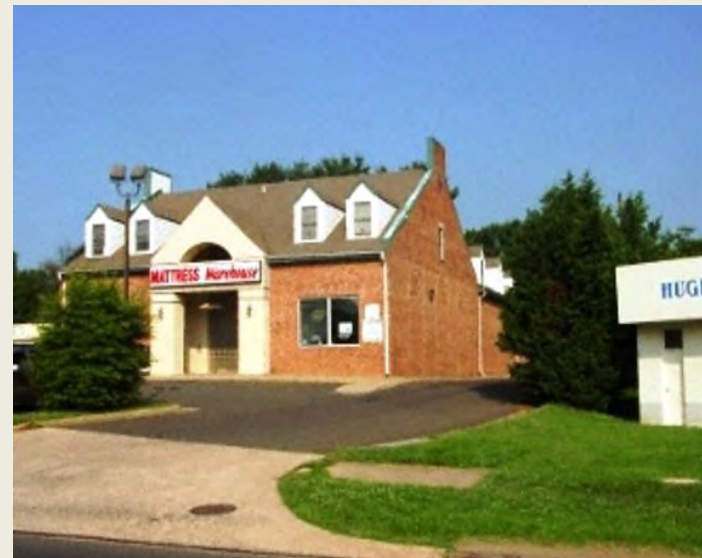
Actual locations in the US of the purported “International Corporate Headquarters” of two shell companies

The top photo shows a basement entrance to a check cashing facility that was listed as the “international headquarters” for a consulting group that won contracts to design a number of construction projects.

The bottom photo shows a retail mattress store in a small town that was listed as the headquarters for a purported international trading and construction firm.
